#### DIABLO CANYON INDEPENDENT SAFETY COMMITTEE

## Report on

# Fact-Finding Meeting at DCPP on December 12 and 13, 2023

## Per Peterson, Member, and Richard McWhorter, Consultant

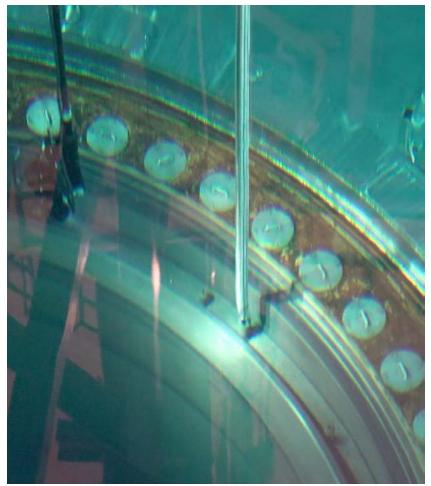
The FFT then requested that PG&E provide a summary of the efforts that were made to retrieve weld coupon Capsule B during Refueling Outage 1R24 that was recently completed in November 2023. Mr. Soenen reported that during a previous attempt to retrieve Capsule B, the tool engaged into the plug on the top of the sample tube but large amounts of force were not successful in removing the plug. During the recent outage, the tool would not engage into the plug on the top of the sample tube. Following the failure of the tool to engage, measurements were taken and it was found that the top of the plug had deformed slightly which resulted in a hole 0.01 inches smaller than the tool. None of the retrieval options planned for the outage could be used without a proper engagement of the tool into the plug.

Unit 1 Reactor Vessel Showing Tool Attempting to Engage Capsule B Sample Tube Top Plug

Regarding future efforts, PG&E reported that additional retrieval options would be available during Refueling Outage 1R25 in the spring of 2025 when the reactor core barrel would be removed to support ISI Program inspections. Also, the tool would be modified prior to that outage to ensure that it would fit into the smaller hole. Mr. Soenen also reviewed with the FFT several alternative approaches that could be used for the embrittlement analysis of Unit 1's Reactor Vessel including the possible use of the 10 CFR 50.61a rule or the possible use of comparable data from the same weld material located at another nuclear power plant.
