**Diablo Canyon  
Independent  
Safety Committee**

**Public Meeting  
June 10 and 11, 2025**

# Diablo Canyon Power Plant: State of the Plant Update

June 10, 2025

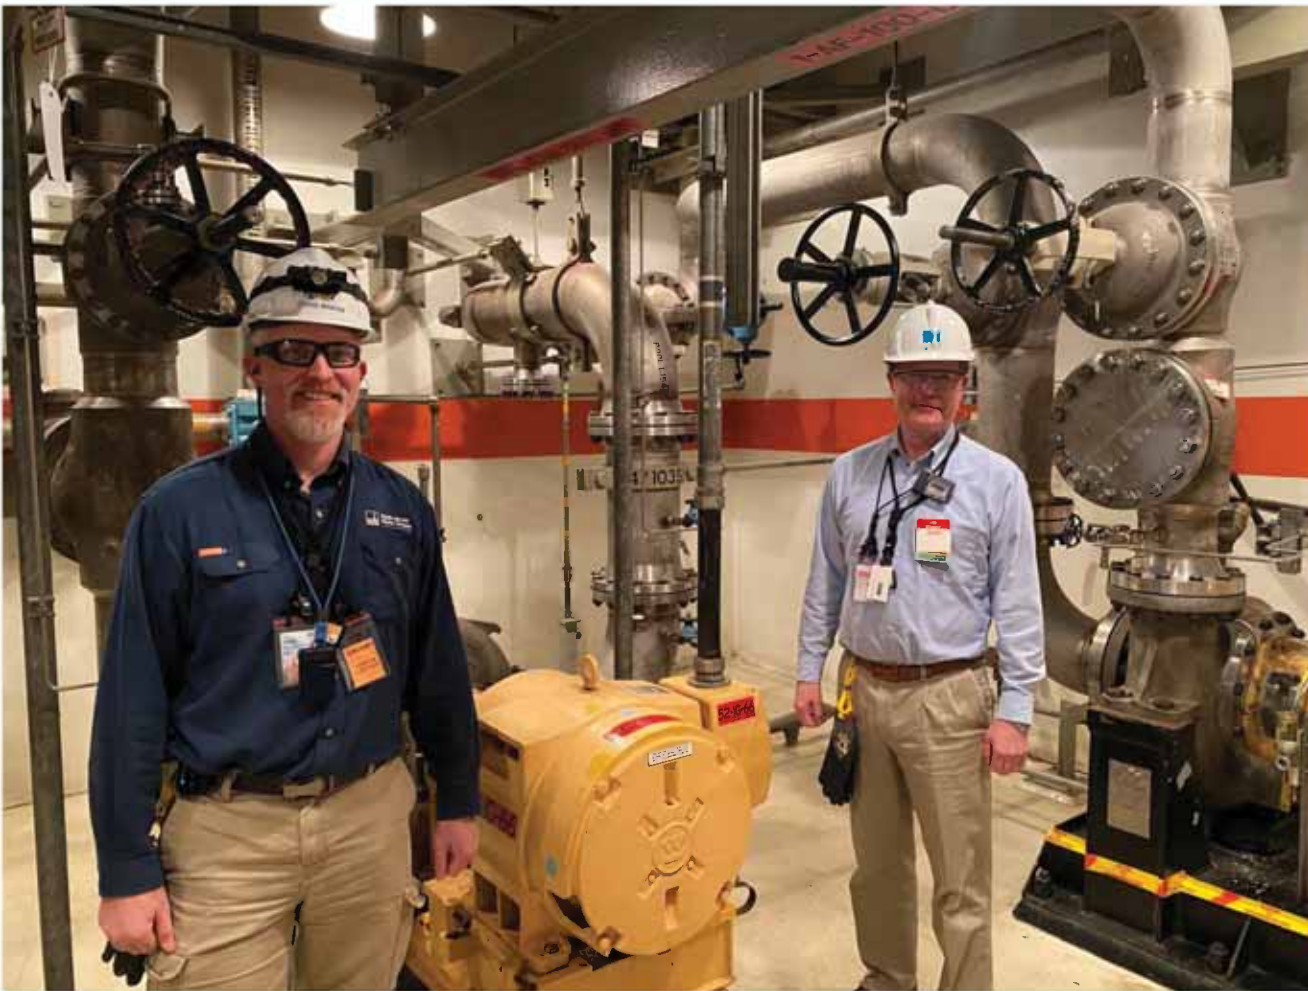
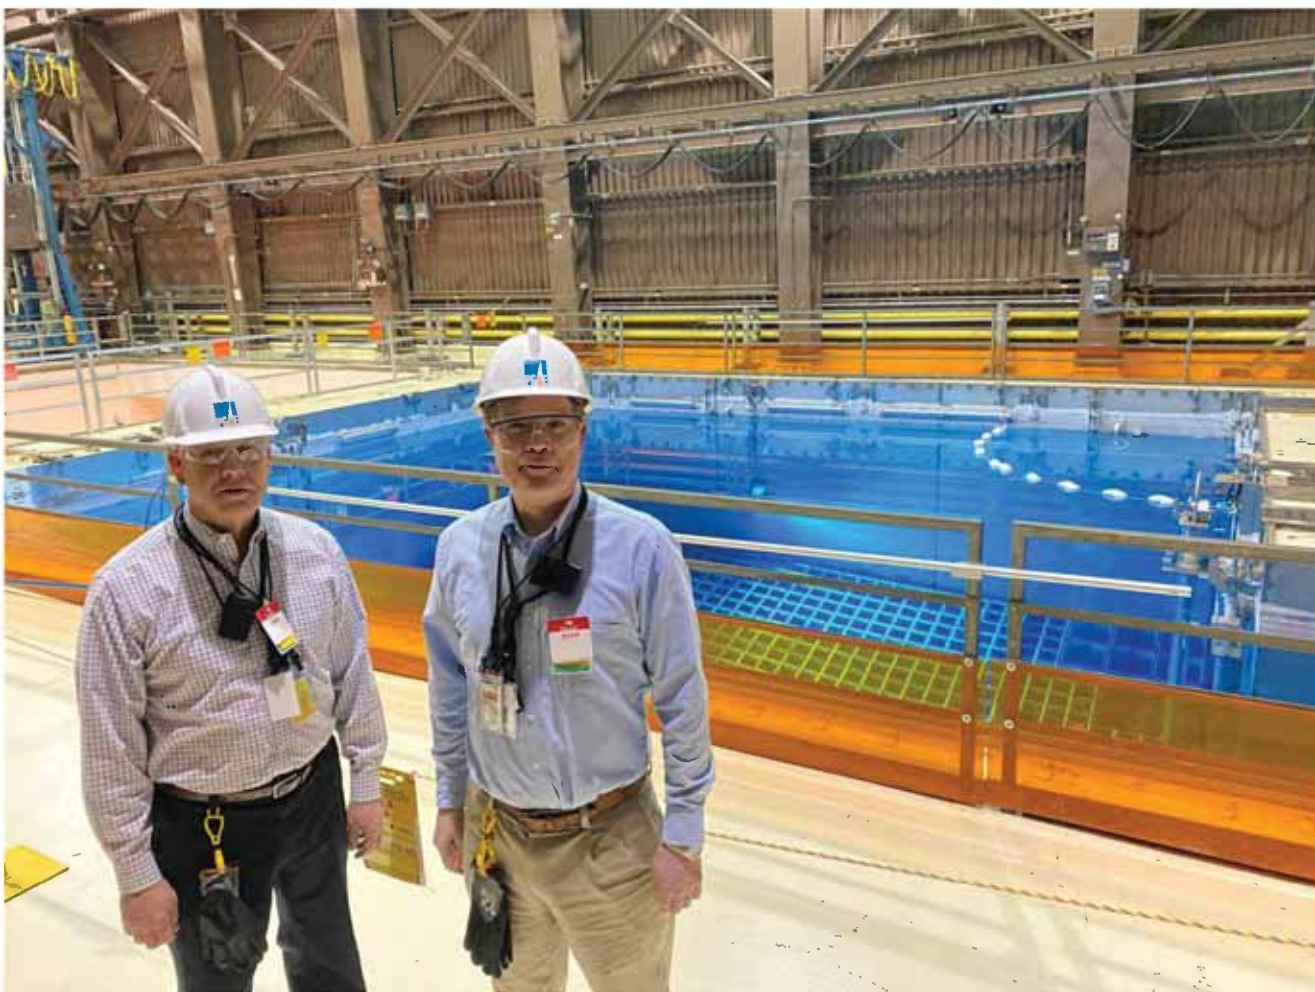
Conclusion: DCCP's Spent Fuel Pool Cooling Systems were in good health with no major issues.

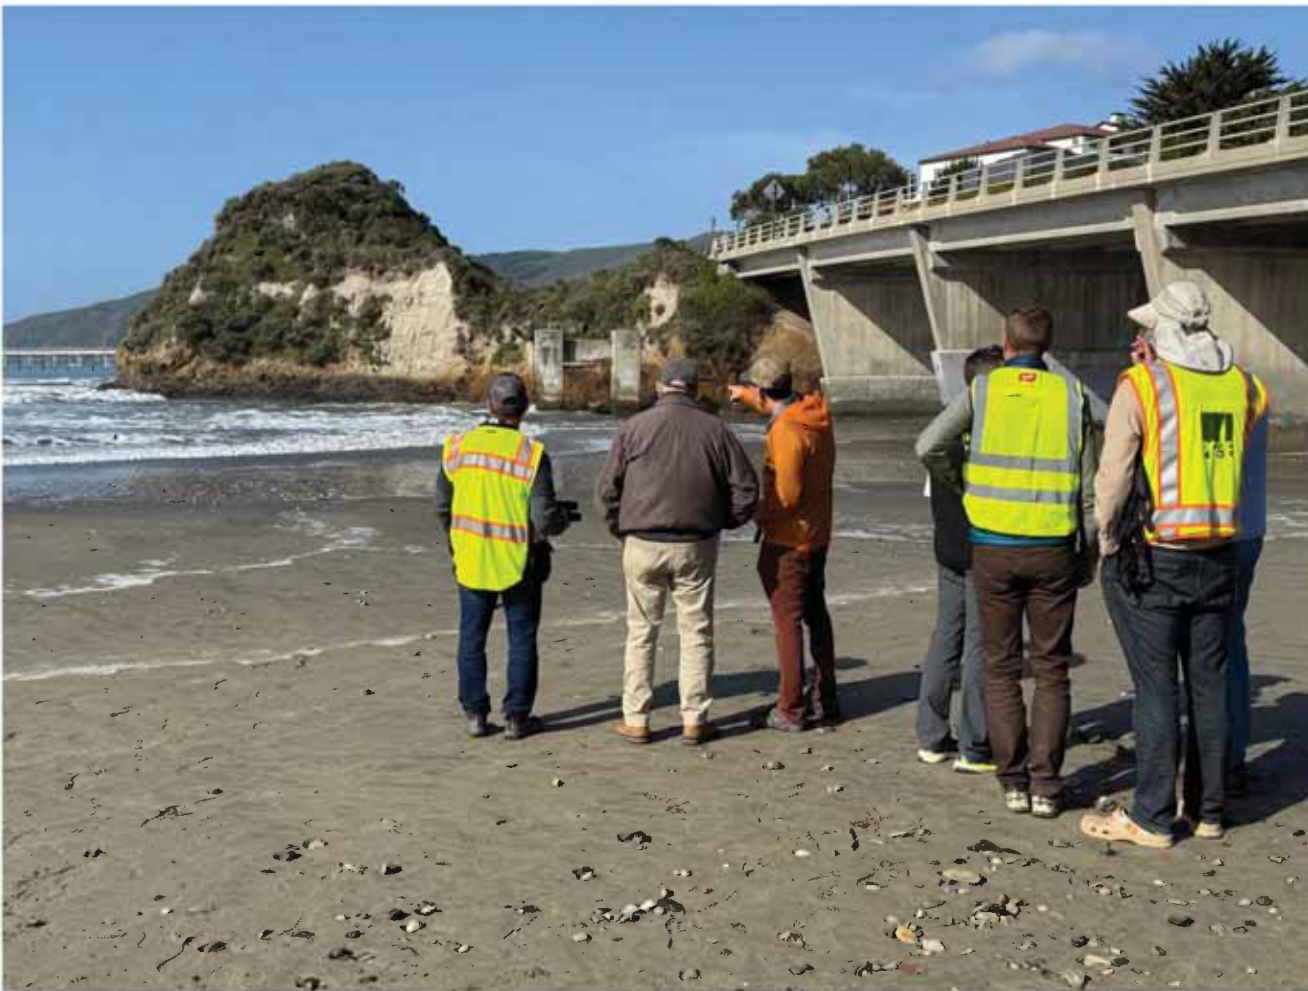
Conclusion: The DCISC's Seismic Review Team and Fact-Finding Team observed geologic formations near DCPD that were significant to understanding faults underlying the Irish Hills, including inspecting rock formations at surface locations of the San Luis Bay Fault.

**SRT and FFT  
Observing Rock Layers  
Indicative of Shoreline  
Fault at Avail Beach**

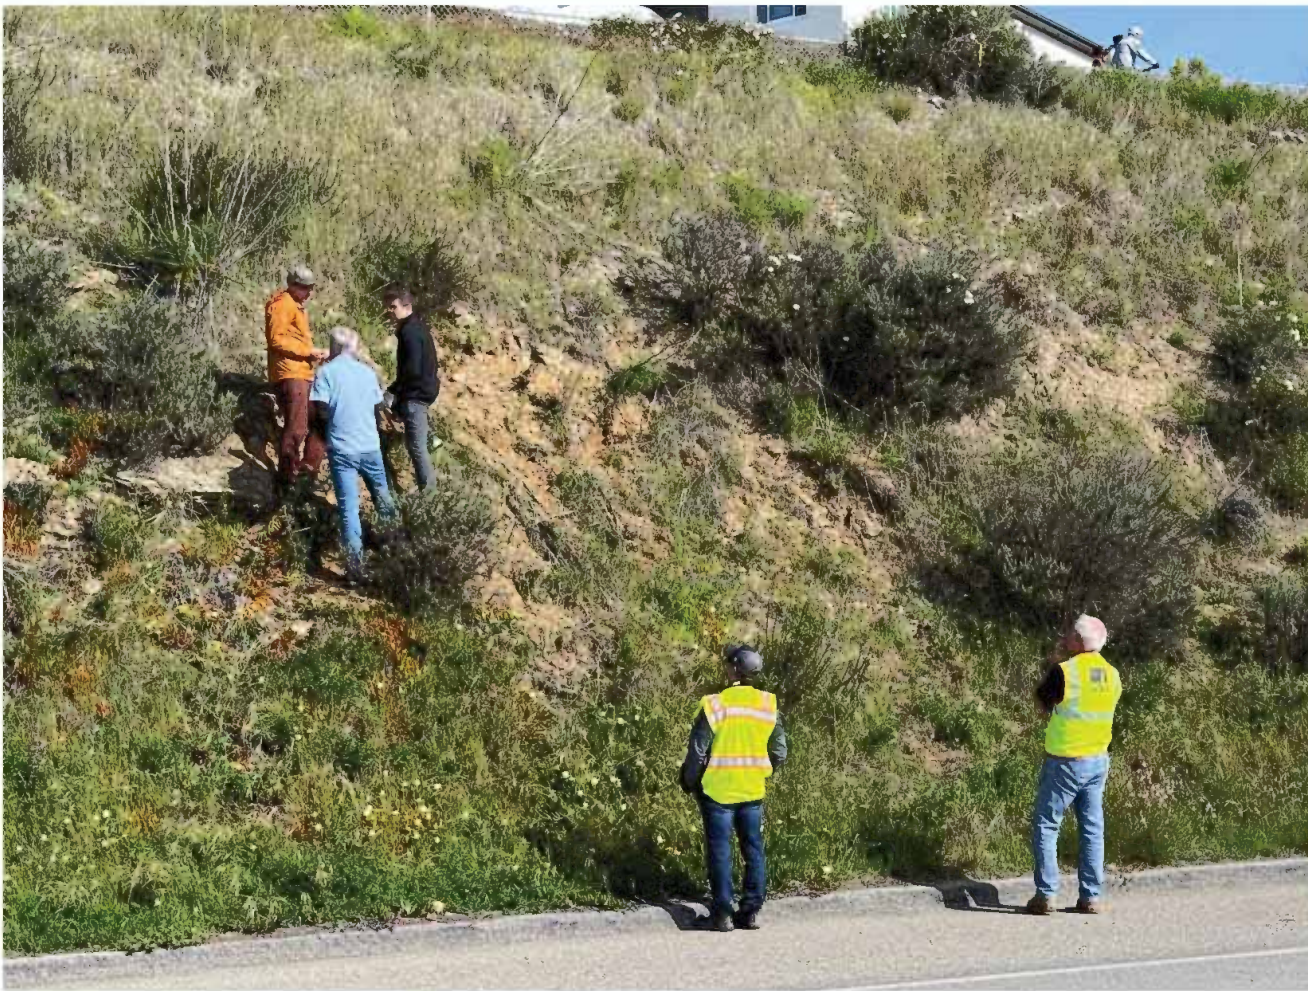
**SRT Observing Rock Layers Indicative of Shoreline Fault Along Avila Beach Drive**

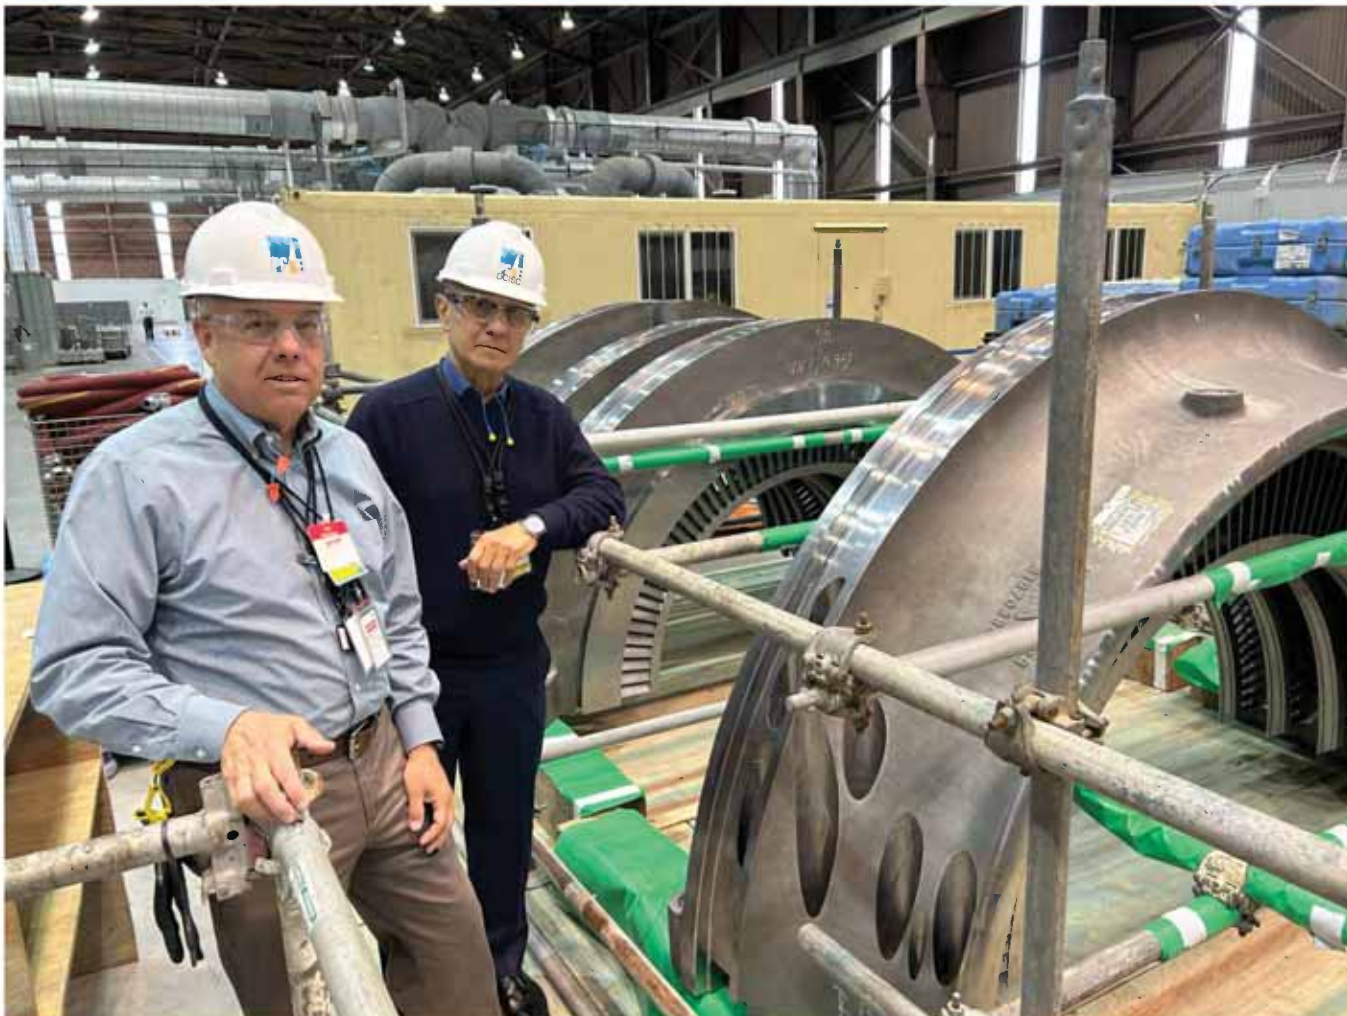
Conclusion: The replacement of DCPD Unit 1's HP Turbine was proceeding satisfactorily. Due to the discovery of higher-than-expected erosion on internal sealing surfaces, DCPD implemented a contingency plan for increasing the scope and duration of the work. The FFT considered that this type of proactive pre-planning was commendable and enhanced safety.

**Mr. McWhorter and  
Dr. Meshkati at  
Replacement HP  
Turbine Stator Elements**

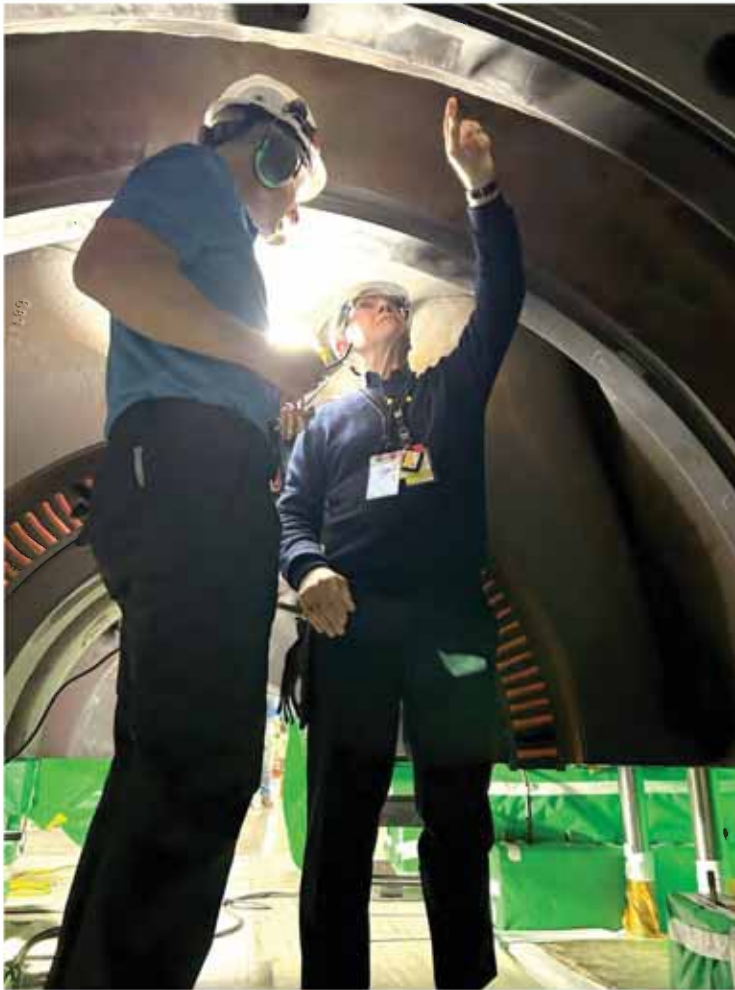
**DCPP Technician  
and Dr. Meshkati  
Under HP Turbine  
Upper Casing**

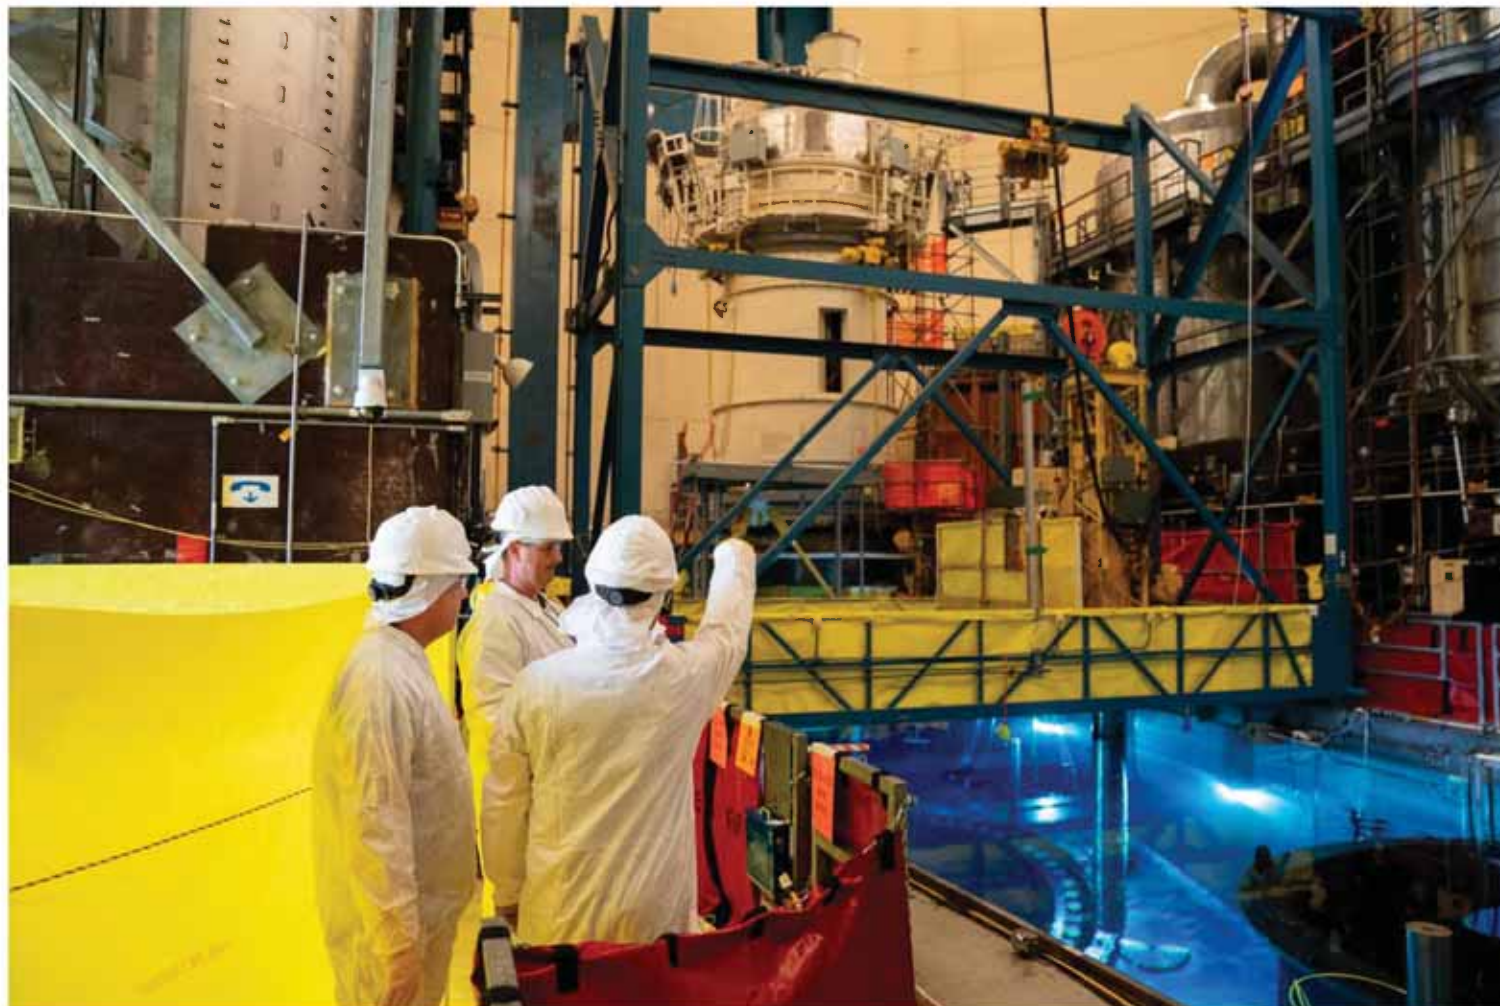
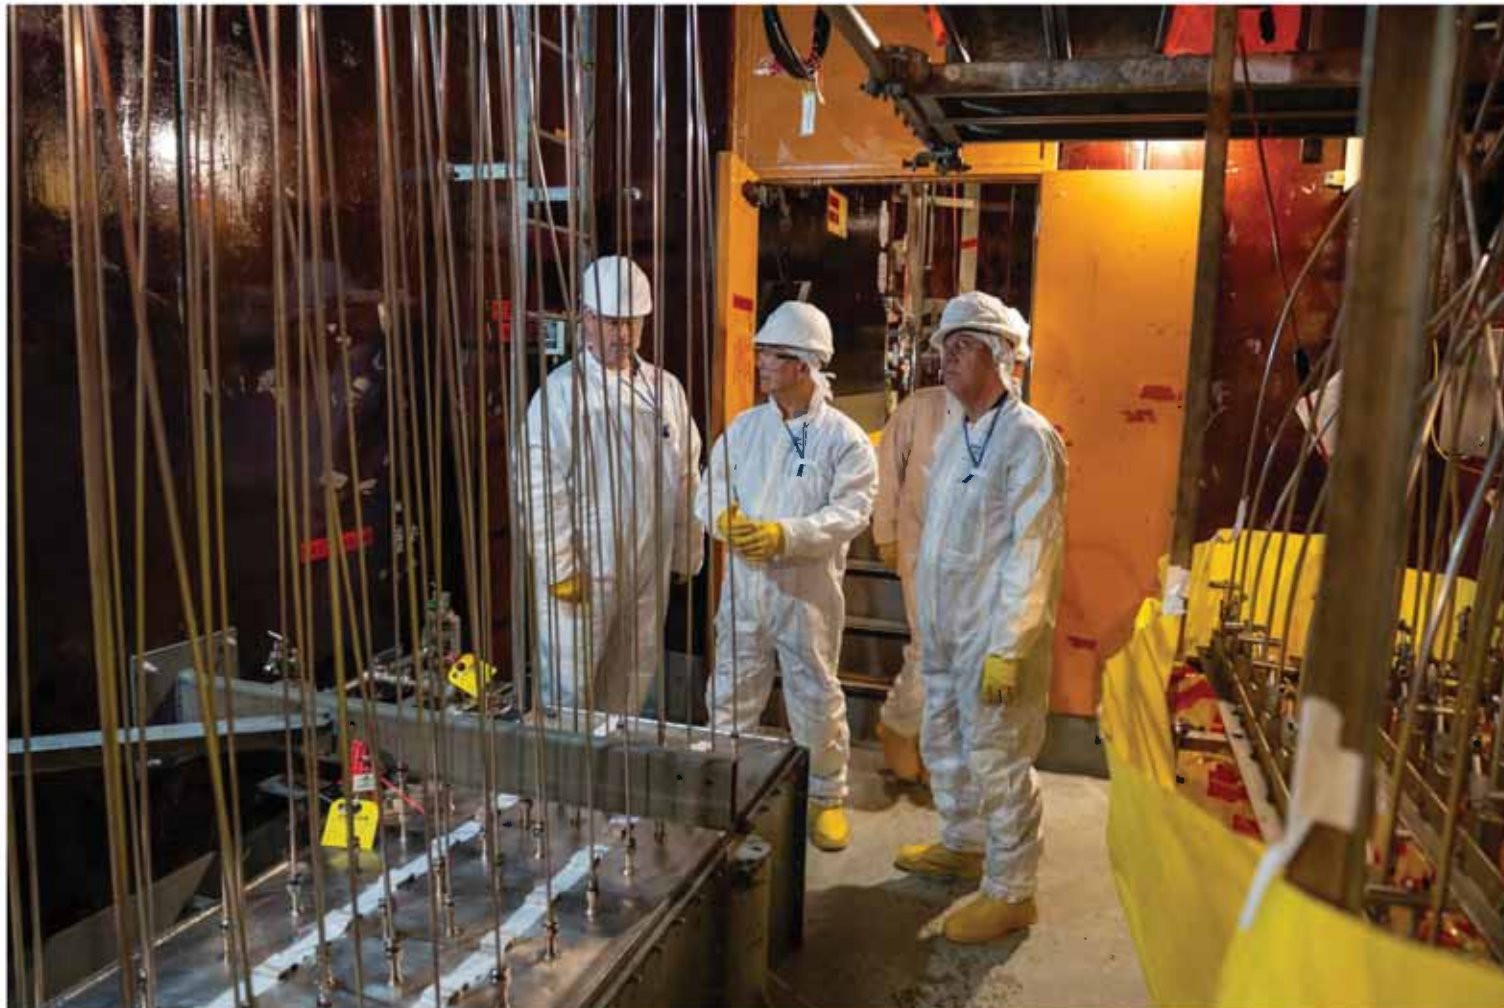
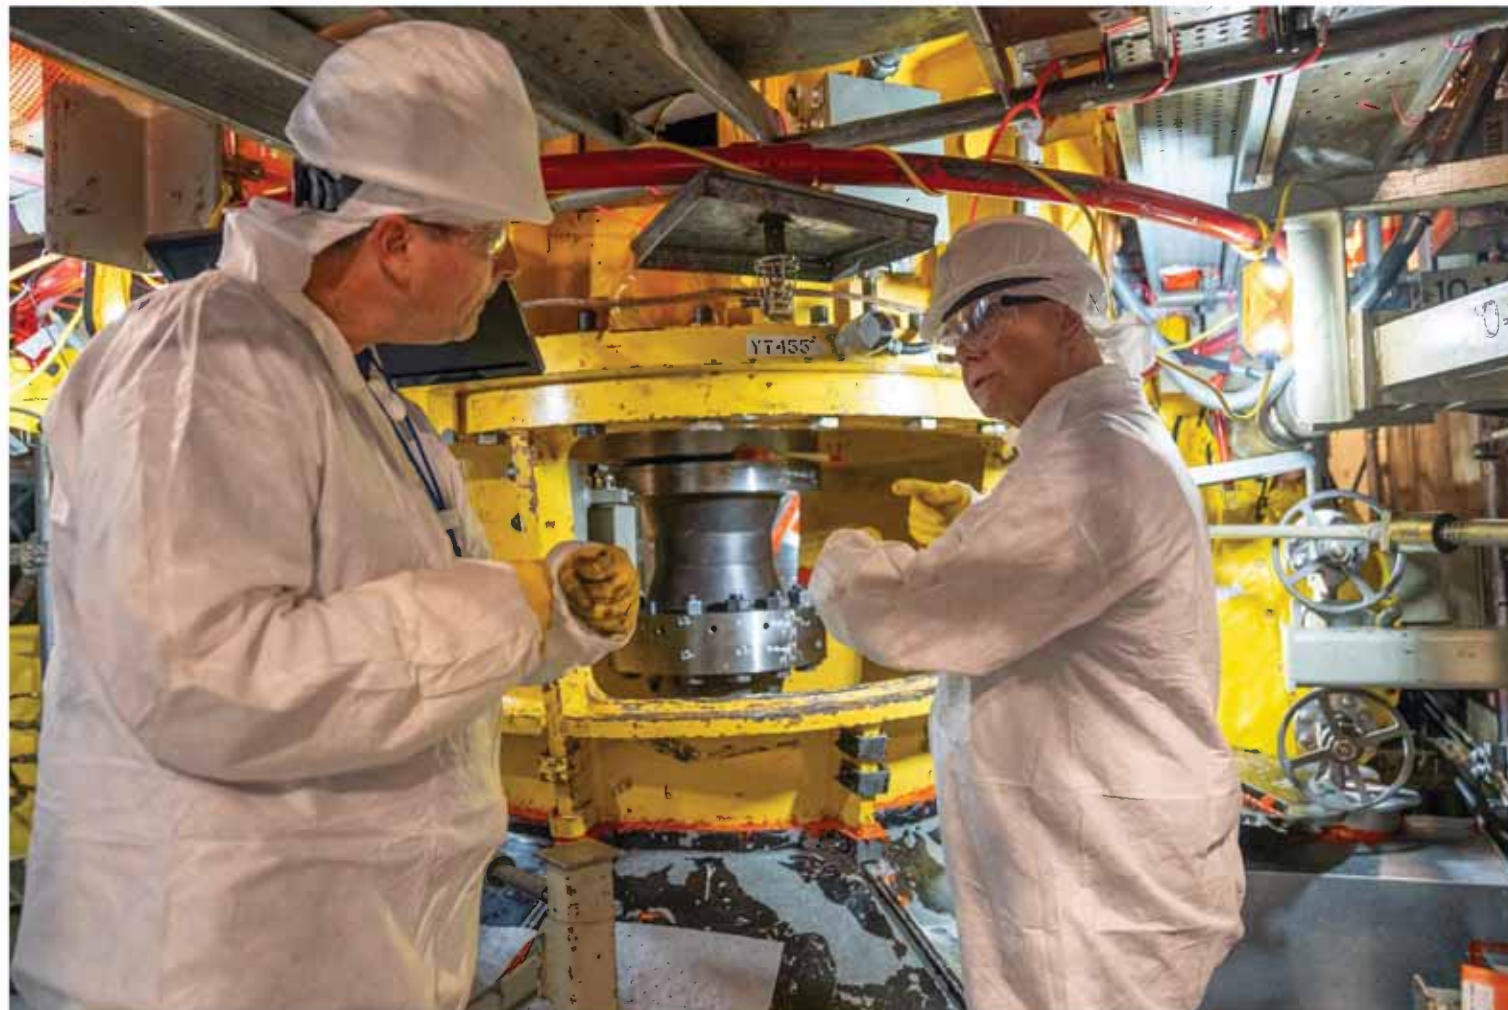
Conclusion: The DCISC Fact-Finding Team toured the DCP Unit 1 Containment and found that all observed areas and equipment were in good condition.

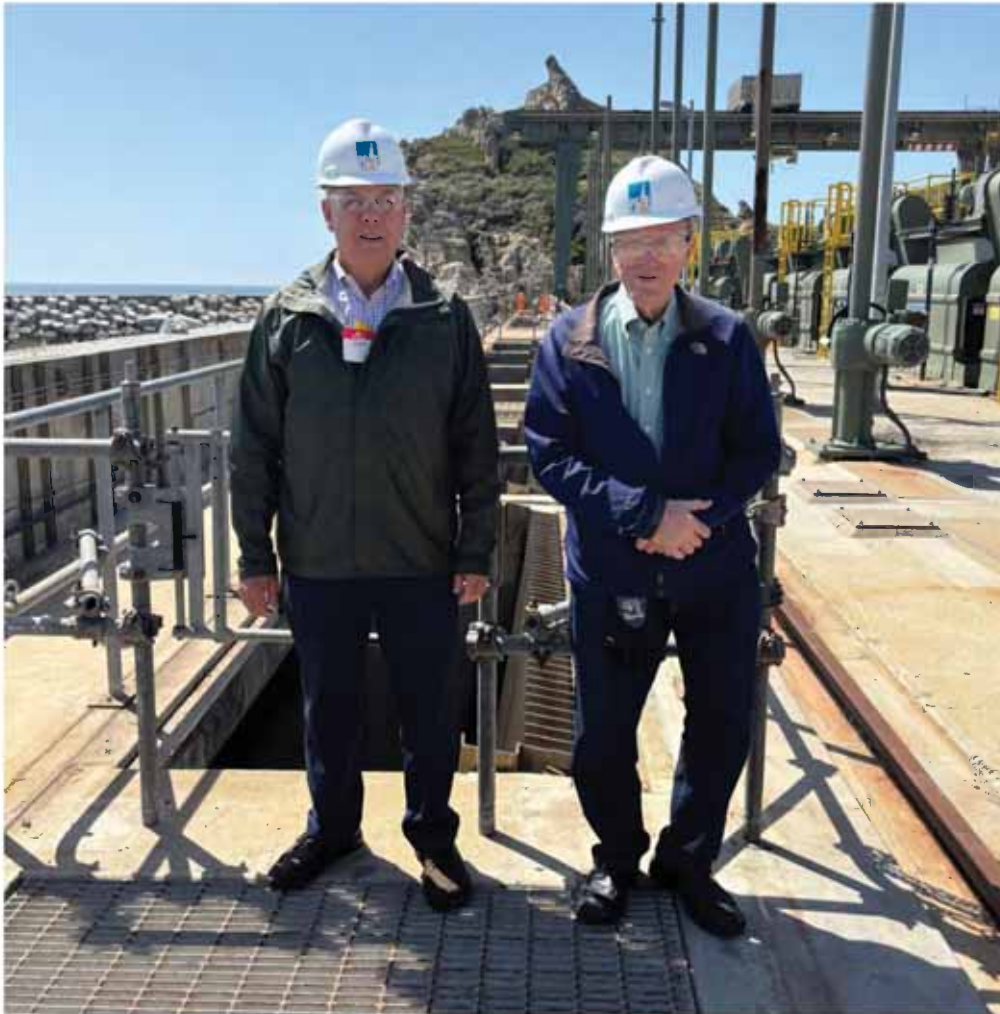
Conclusion: A tour of the Intake Structure found it to be in good condition with only small amounts of concrete degradation.
