## **DIABLO CANYON INDEPENDENT SAFETY COMMITTEE**

### **Fact-Finding Meeting at DCP on April 28 and 29, 2025**

**Najmedin Meshkati, Member, and Richard McWhorter, Consultant**

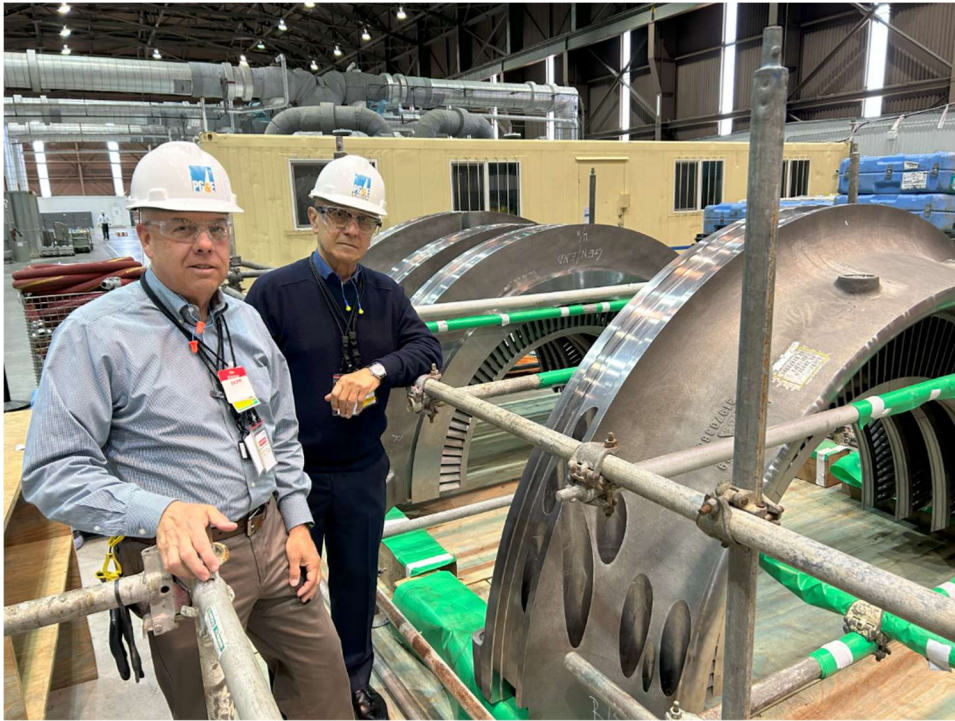
Mr. McWhorter and Dr. Meshkati at the New Unit 1 HP Turbine Stator Elements

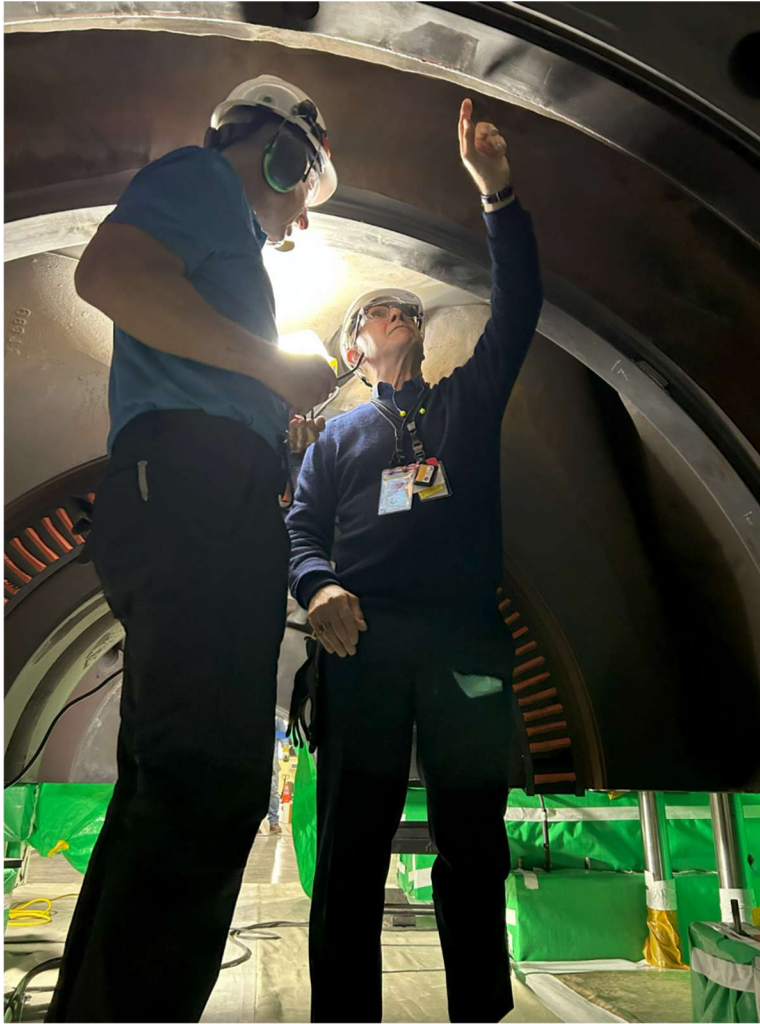
DCPP Technician and Dr. Meshkati Looking at Weld Repairs Under the HP Turbine Upper Casing

The FFT found that the work area for the HP Turbine replacement was clean, well-organized, and provided a safe work environment. The FFT was able to directly observe the weld repairs that were being performed on the HP Turbine casing. The team asked where the necessary proficient welder resources were found to perform the work on short notice, and Mr. Brass reported that sufficient qualified welders were already on site performing other work, and those welders had been temporarily reassigned to the higher-priority HP Turbine work.

**Conclusions:** The planned replacement of DCPD Unit 1's High-Pressure Turbine was proceeding satisfactorily. Due to the discovery of higher-than-expected erosion on internal sealing surfaces, DCPD had implemented a contingency plan for increasing the scope and duration of the work. The FFT considered that this type of proactive pre-planning was commendable and enhanced safety by providing a methodical approach to resolving a major issue with minimal disruption to other outage activities. The DCISC Fact-Finding Team

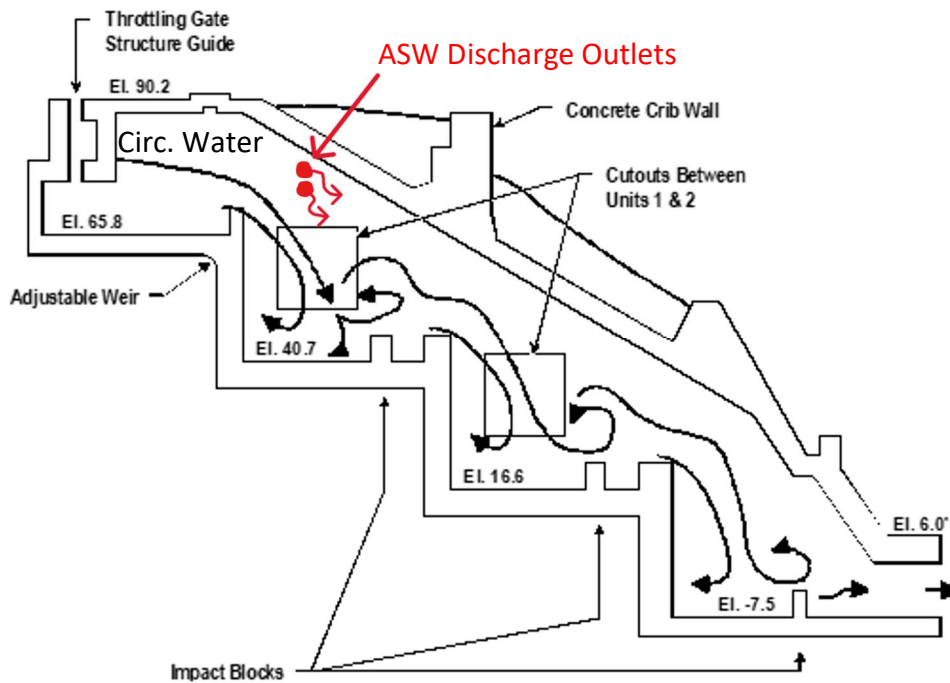
Cross-Section of the DCPD Circulating Water Discharge Structure Showing the Approximate Locations of the ASW System Discharge Outlets in the Sides of the Structure (red dots; added by the FFT)

Mr. Conklin confirmed that the FFT's understanding of the configuration of the Discharge Structure and the location of the ASW System discharge outlets was correct. The FFT further explained that it believed that a collapse of the Discharge Structure in such a manner as to completely block flow was extremely unlikely, but it was possible. The possibility of this scenario (and its low probability) was also supported by similar statements made in the UFSAR. Given that the scenario was possible, the FFT inquired if such a scenario was included in the scope of the FLEX program analyses and FLEX guideline development. Mr. Conklin stated that there were no existing FLEX guidelines for this scenario and that further research would be required to understand if and how this scenario may have been addressed in the past analyses that formed the basis for the current FLEX Program. He agreed that this was a question worth researching and further review. The FFT concluded that a further review was warranted and recommended that PG&E review if and how the FLEX Program addressed the effects of a possible collapse of the Discharge Structure or other obstructions on the ASW System discharge flow path.

**Conclusion:** The DCISC found that a possible collapse of the DCPD Discharge Structure onto the Auxiliary Saltwater discharge outlets was highly unlikely but possible. This scenario should be further reviewed to determine if it should be included as a part of the FLEX Program. A tour of the Discharge Structure found it to be in sound condition with small amounts visible degradation from its exposure to the weather and saltwater.

**Recommendation to PG&E:** PG&E should review if DCPD should have considered developing FLEX guidelines for providing an alternative discharge path for the Auxiliary Saltwater (ASW) System following a Beyond Design Basis event that may cause a collapse of the Discharge Structure or otherwise obstruct the ASW System discharge (P4/25FF-3.6). PG&E has accepted this recommendation and is working to address it under Notification 51283374.

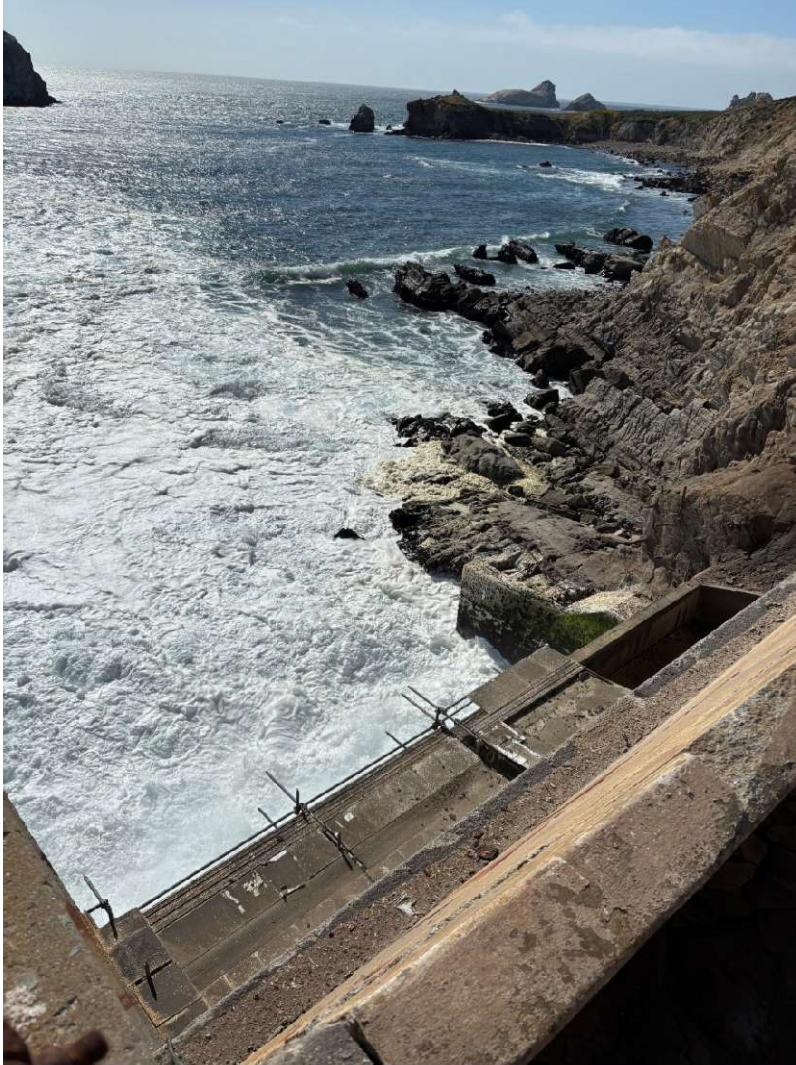
Discharge Structure Viewed from Access Stairway

The FFT found that the Discharge Structure was clean and in sound condition with small amounts of visible degradation from its exposure to the weather and saltwater.

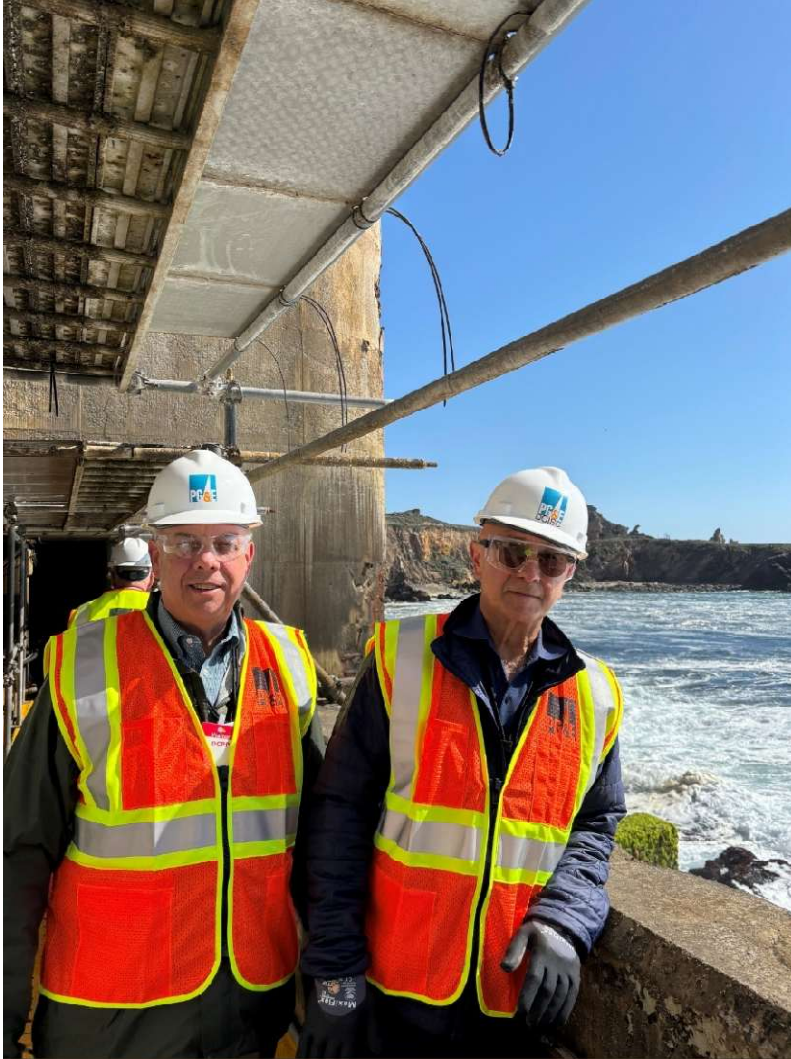
Mr. McWhorter and Dr. Meshkati at Discharge Structure Lower Walkway

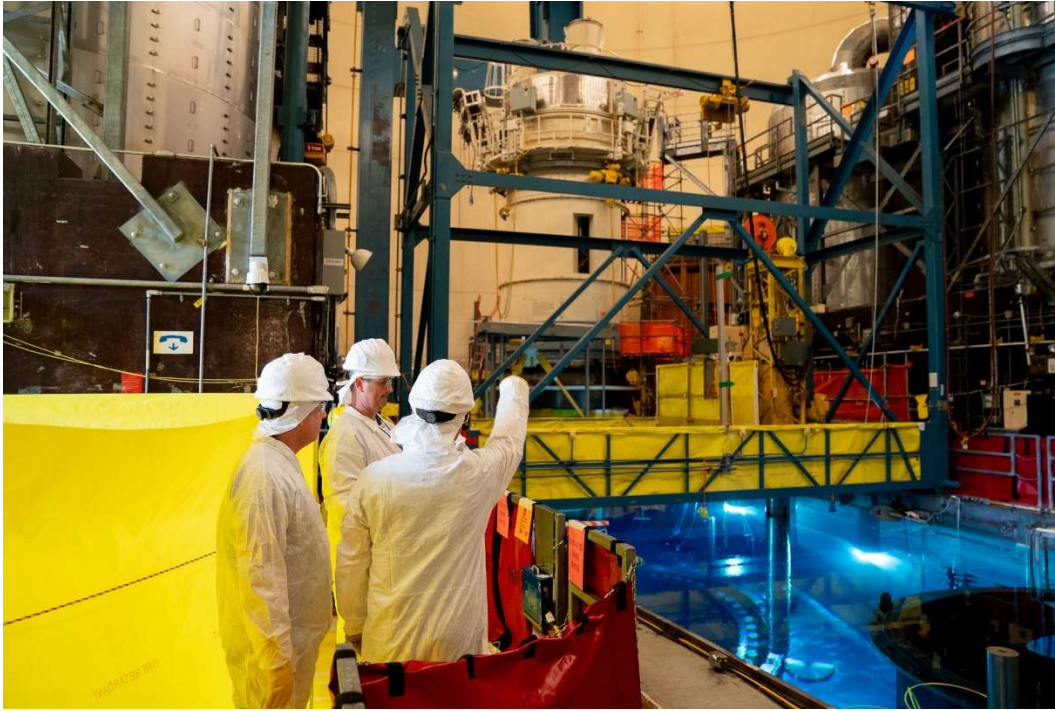
Overall, the FFT found that all observed areas were clean, orderly, well lit, with equipment in good condition, and radiation hazard warning signs appropriately posted. Selected pictures of areas toured by the FFT were as follows:

Mr. McWhorter, Mr. Soenen, and Dr. Meshkati at the Reactor Cavity

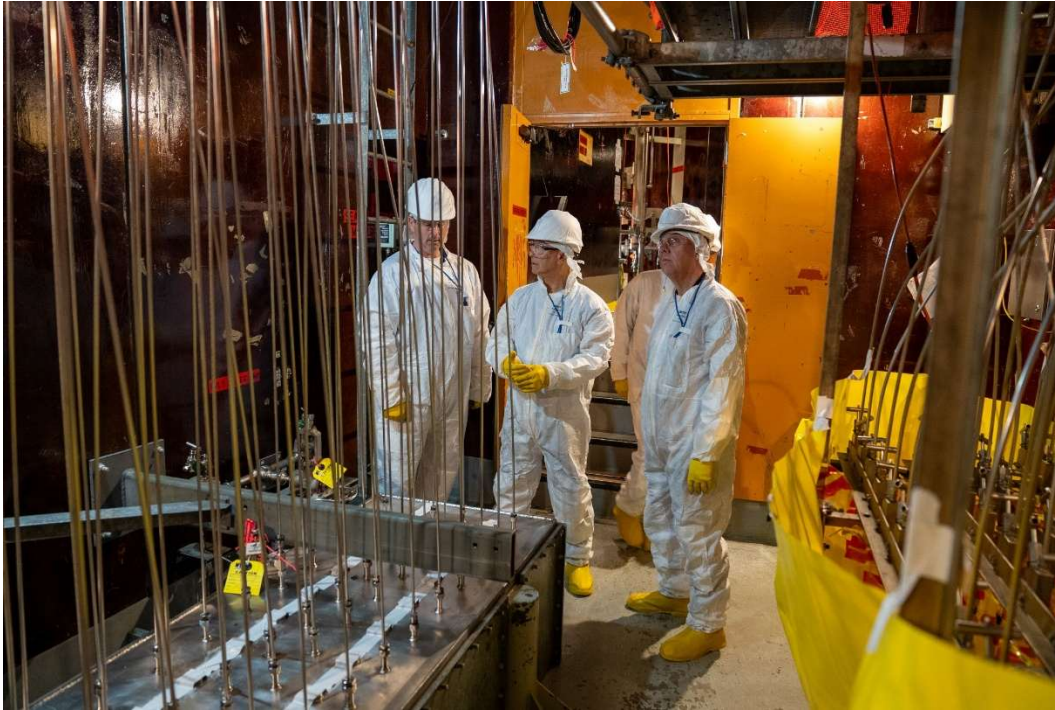
Mr. Soenen, Dr. Meshkati, and Mr. McWhorter at the Nuclear Instrument Seal Table

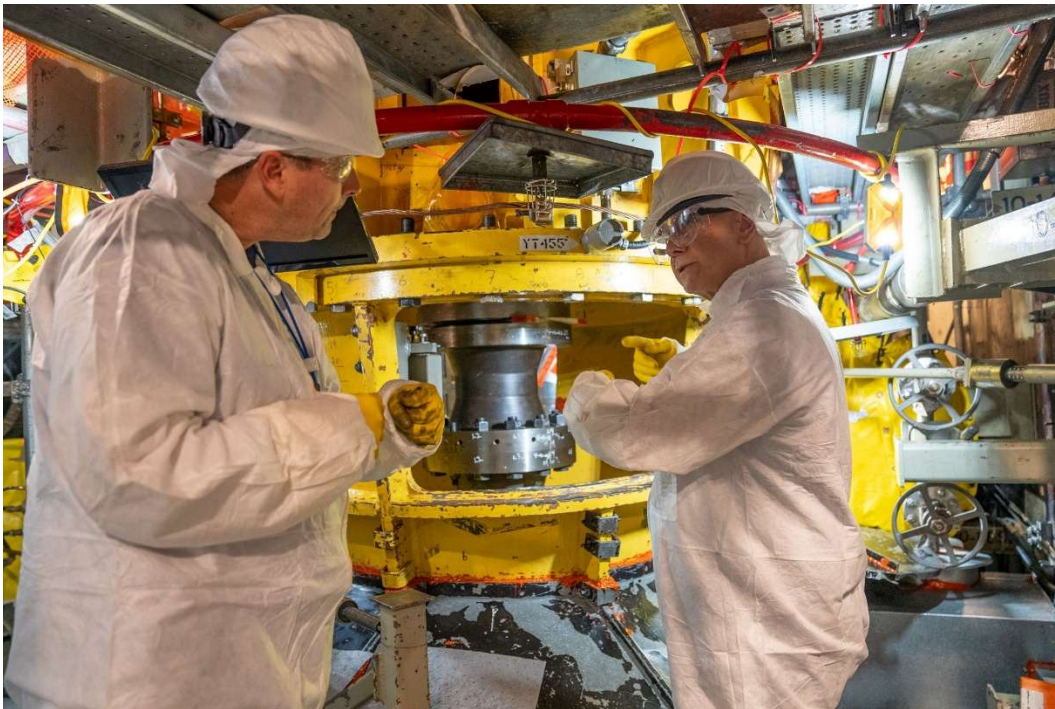
Mr. Soenen and Dr. Meshkati at Reactor Coolant Pump 1-3 Motor/Pump Coupling
