**DIABLO CANYON INDEPENDENT SAFETY COMMITTEE**

**Fact-Finding Meeting at DCP  
on September 16 and 17, 2025**

**Robert Budnitz and Richard McWhorter, Consultants**

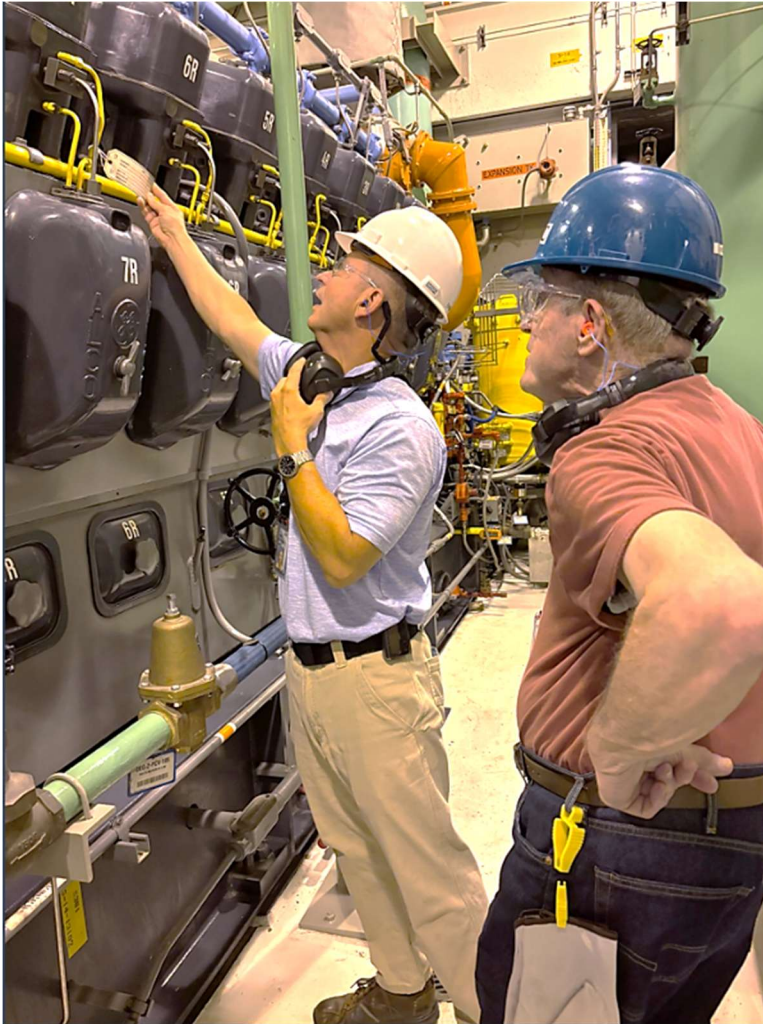
Mr. LaChance and Dr. Budnitz at the 2-2 Emergency Diesel Generator

Overall, the FFT found that the areas toured were clean, orderly, and well lit, with equipment in good condition.

**Conclusion:** A tour of two Unit 2 Emergency Diesel Generator Rooms found them to be clean and orderly with equipment in good condition.
