**Diablo Canyon  
Independent  
Safety Committee**

**Public Meeting  
June 10 and 11, 2025**

# Diablo Canyon Power Plant: State of the Plant Update

June 10, 2025

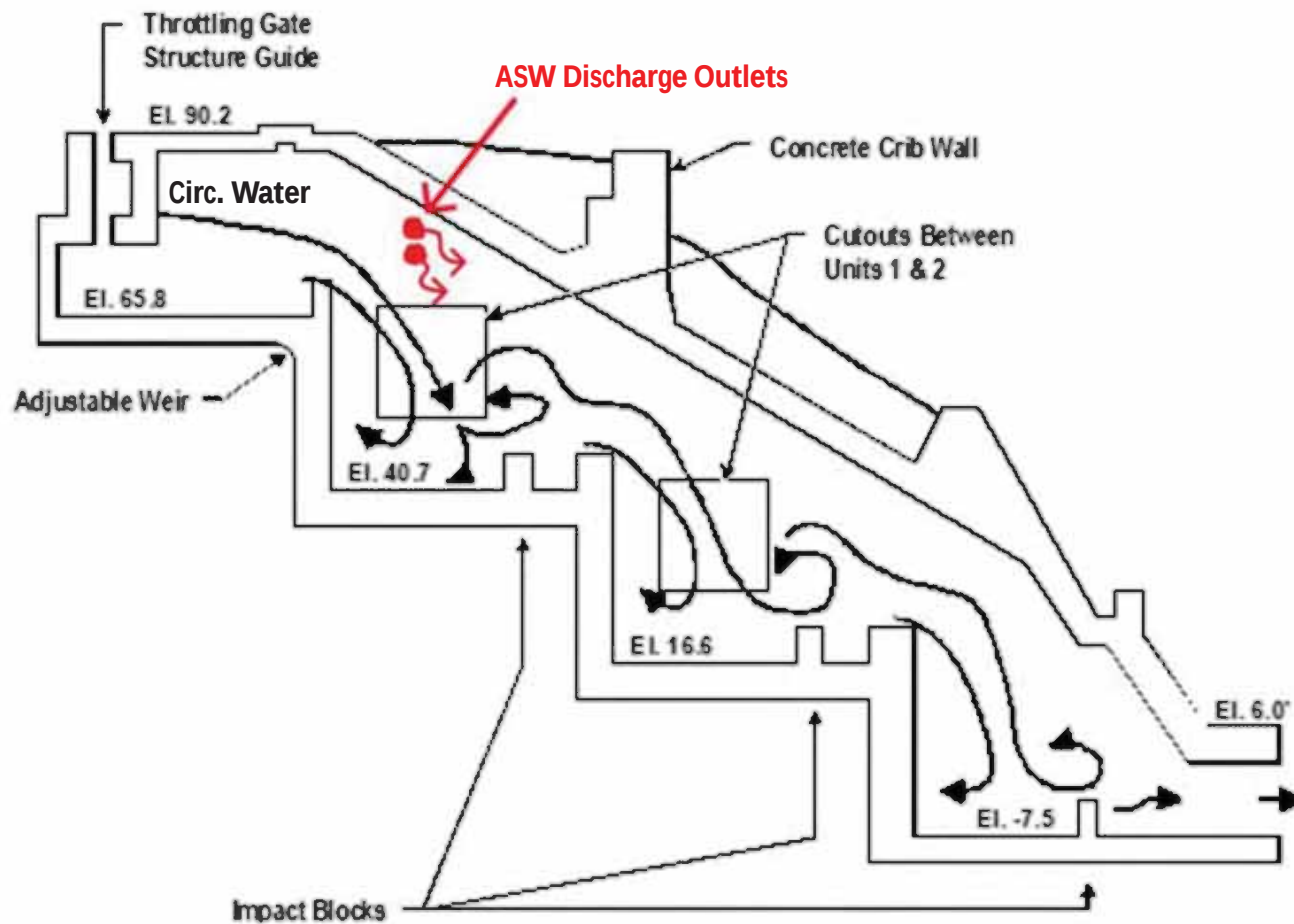
**ASW Discharge Arrangement in Discharge Structure**

- Follow-up from January 2025 Discussions on New Tsunami Analysis
- Post-January Visit, Drawing Provided Raised Question on Configuration of Auxiliary Saltwater (ASW) Discharge Piping in Discharge Structure
- ASW Discharges Located Under Concrete Structure and Earthen Fill
- Discussed Configuration and Toured Area
- Not a Regulatory Concern; Addressed in Safety Analysis Report
- Questioned Why No Guidelines for Loss of ASW Discharge Included in FLEX Program
- PG&E Agreed to Research Question Further and Provide a Future Response

Conclusion: The DCISC found that a possible collapse of the DCPD Discharge Structure onto the Auxiliary Saltwater discharge outlets was highly unlikely but possible. This scenario should be further reviewed to determine if it should be included as a part of the FLEX Program. A tour of the Discharge Structure found it to be in sound condition with small amounts visible degradation from its exposure to the weather and saltwater.
