**DIABLO CANYON INDEPENDENT SAFETY COMMITTEE**

**Fact-Finding Meeting at DCP  
on September 16 and 17, 2025**

**Robert Budnitz and Richard McWhorter, Consultants**

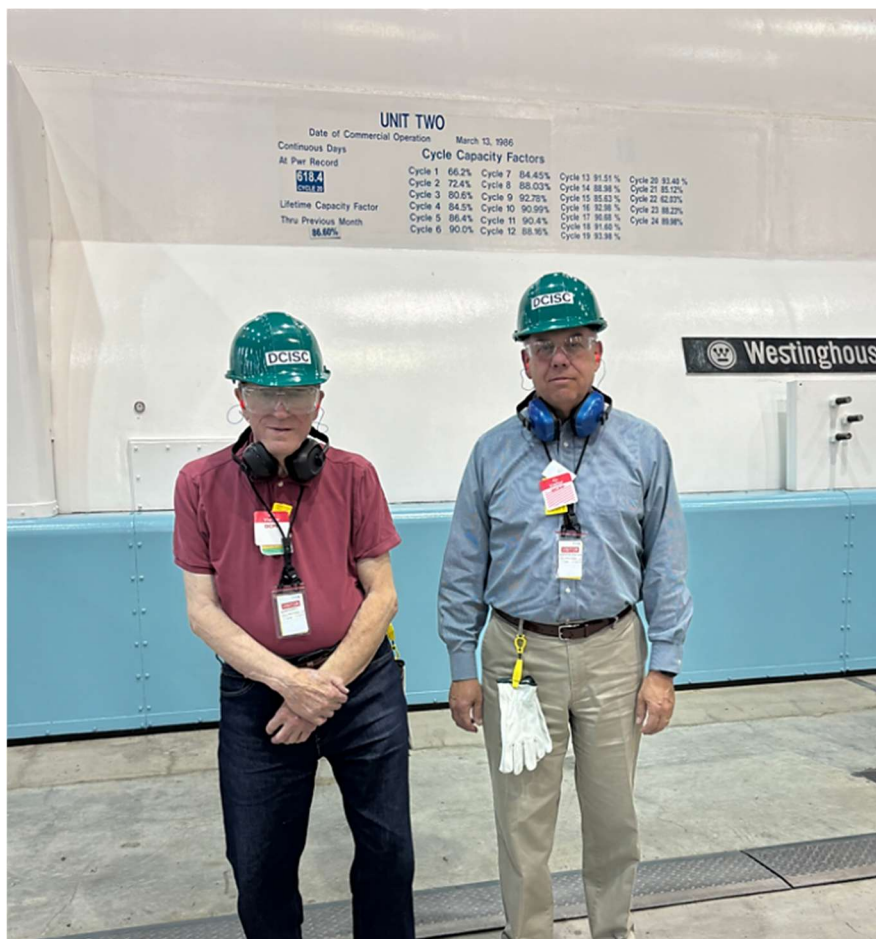
Dr. Budnitz and Mr. McWhorter at Unit 2 Main Generator

Overall, the FFT found that the areas toured were clean, orderly, and well lit, with equipment in good condition.
