## **DIABLO CANYON INDEPENDENT SAFETY COMMITTEE**

### **Report on**

### **Special Fact-Finding Meeting at DCP on March 28, 2025**

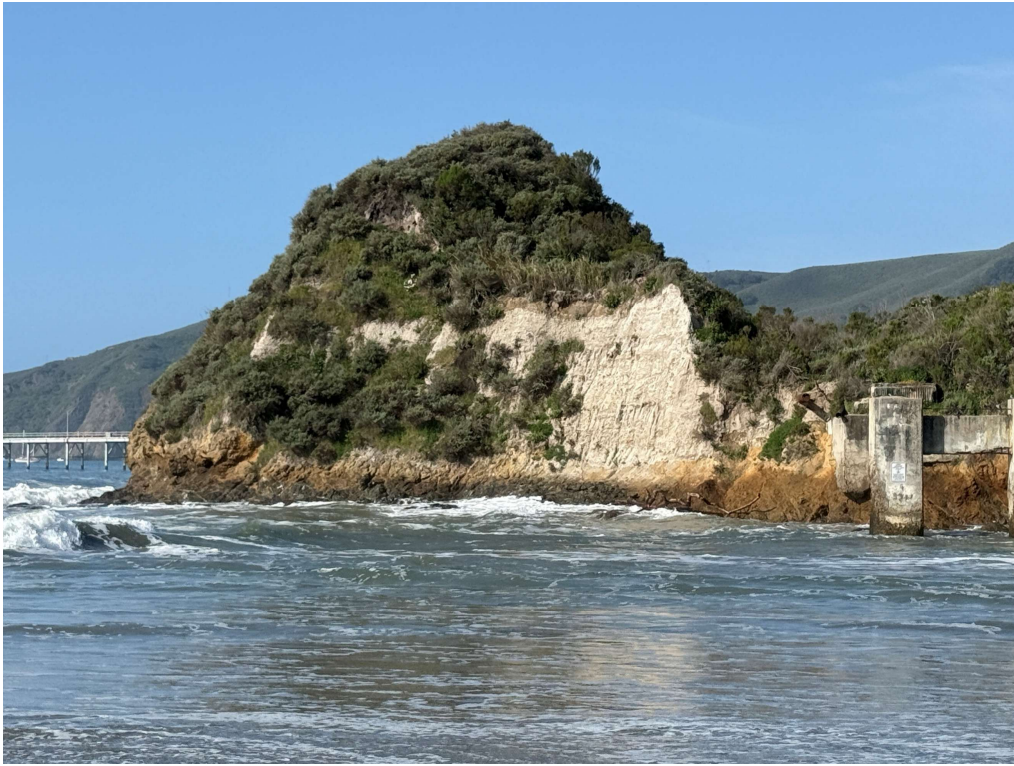
Formation Showing Squire Formation (Tan) on Top of Franciscan Bedrock (Black) at San Luis Bay Fault which comes to the surface near the mouth of San Luis Obispo Creek.

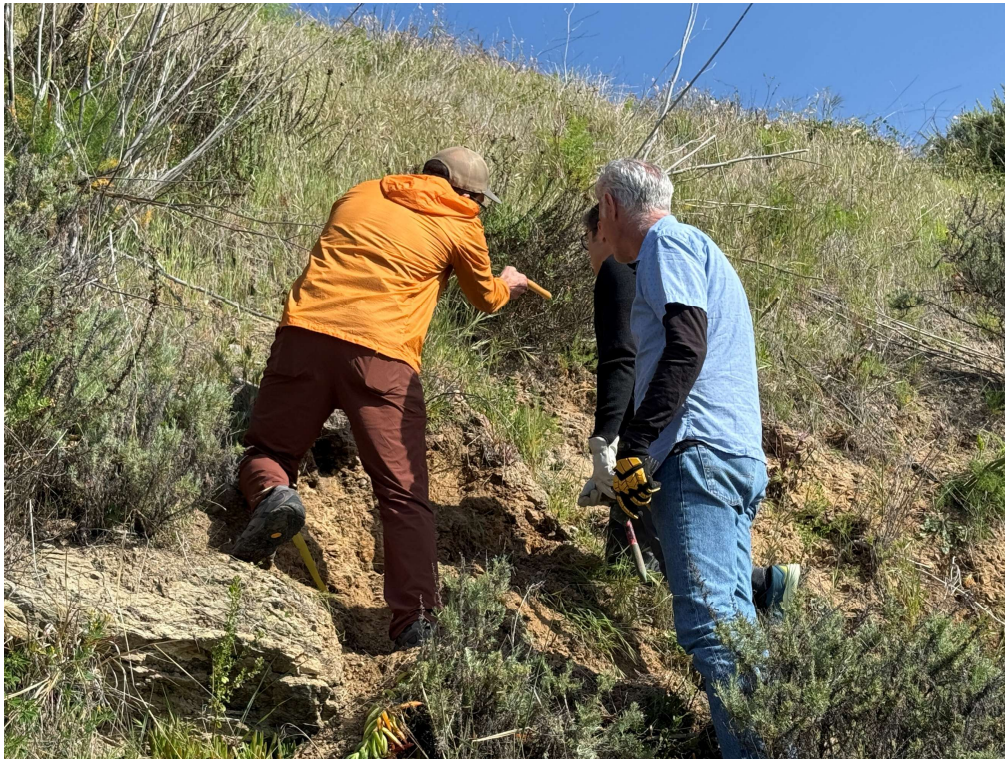
SRT Examining Rock Formation Showing Folding of Layers where the San Luis Bay Fault can be seen on the surface near the mouth of San Luis Obispo Creek.
